J.A.G. Home Inspection

Inspection Report

Property Address: 342 Quail Run Calliham Texas 78007

PROPERTY INSPECTION REPORT

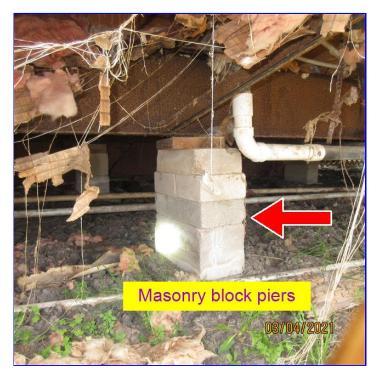
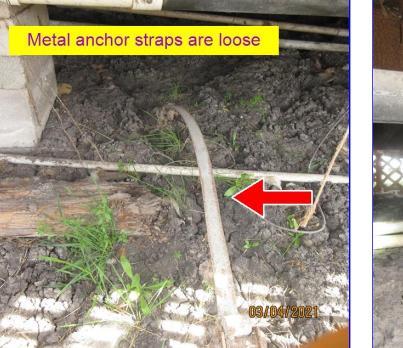
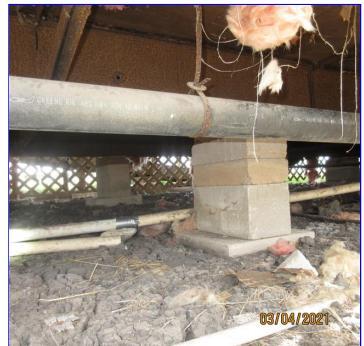
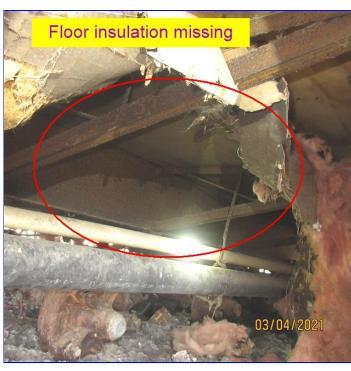
This foundation appears to be functioning as intended with some settlement shown by uneven interior floors and the master bathroom door dragging against the floor.

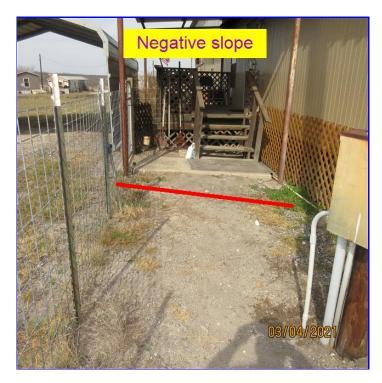
Soil is pulling away or cracking at foundation, recommend adding soaker houses around foundation to prevent settlement.

There is a negative slope at the right side (facing front) and can cause or contribute to water intrusion into the crawlspace. I recommend correcting landscape to drain water away from home.

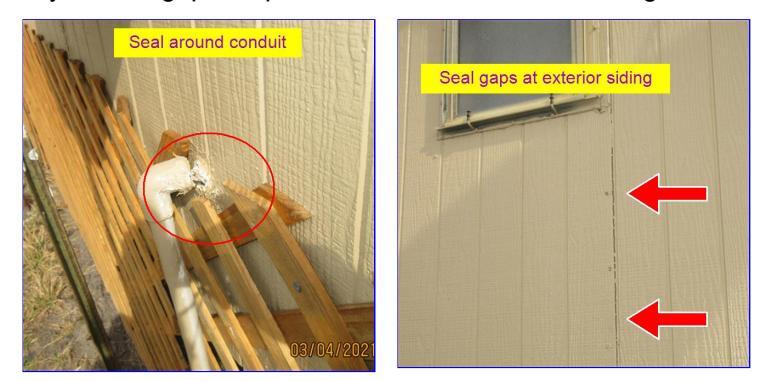
Any cracks, gaps, or penetrations in the exterior siding should be sealed to prevent water intrusion.

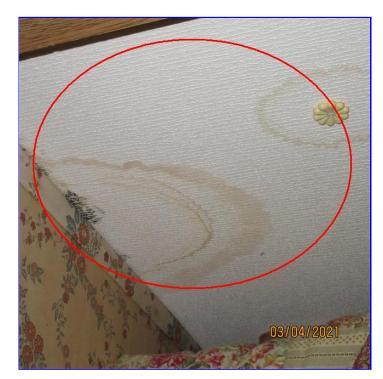
Previous water stains at bedroom closet.

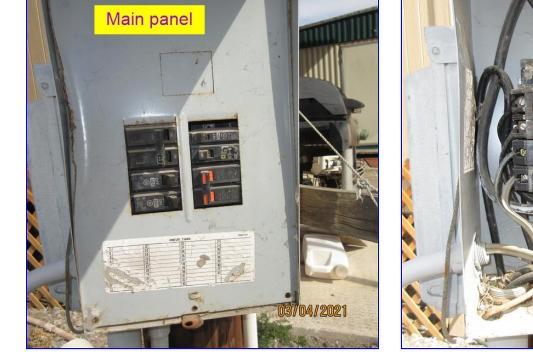
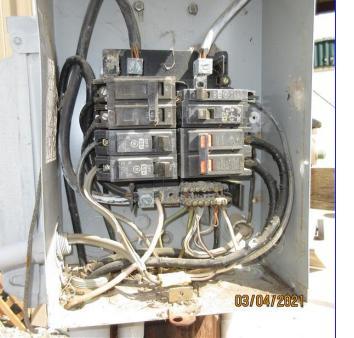
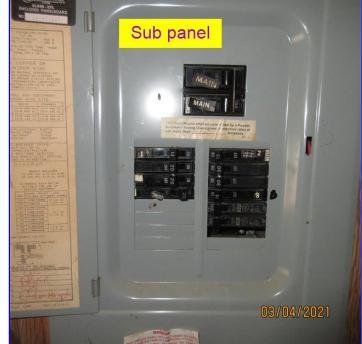
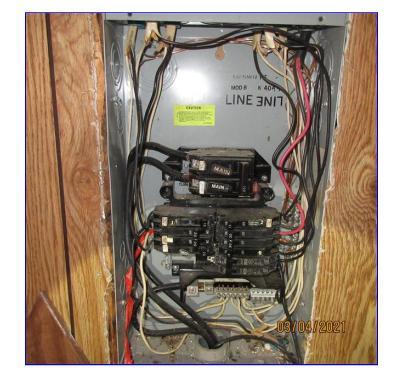
There are several breaker's without labels at the panels, I recommend repairs.

The main lug is double tapped at the main outdoor panel, there should only be one conductor (wire) under each screw or lug. <u>I recommend contacting a licensed electrician for further evaluation and repairs to this system.</u>

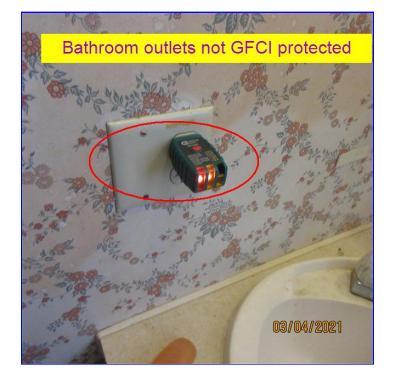
Any outlets in wet areas such as outdoors, kitchen, and bathrooms should be GFCI protected, I recommend repairs.

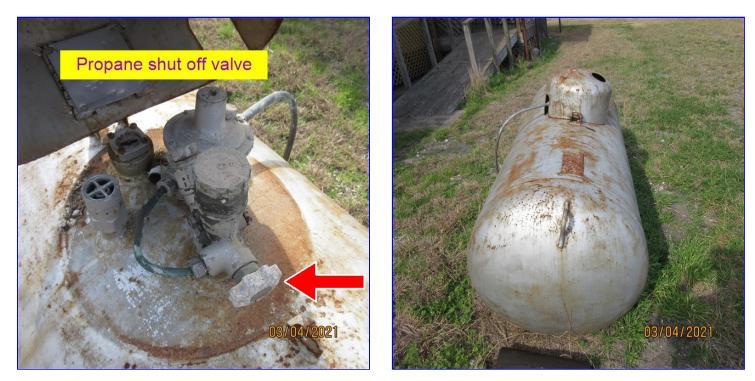
The propane supply appears to be empty, I recommend further evaluation.

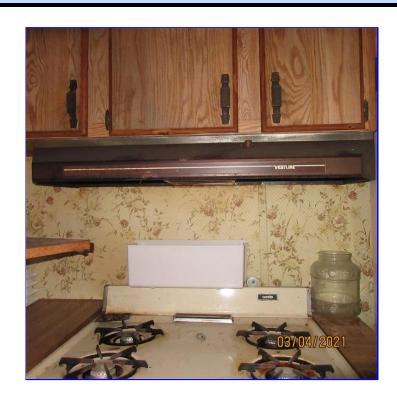
I NINP D	
	V. Appliances
□ □ ⊻ □ A.	Dishwasher Comments:
	Not present.
□ □ ⊻ □ B.	Food Waste Disposers Comments:
	Food disposer not present.
☑ 🗆 🗆 ☑ C.	Range Hood and Exhaust System Comments:
	Vent hood did not function, I recommend replacement.

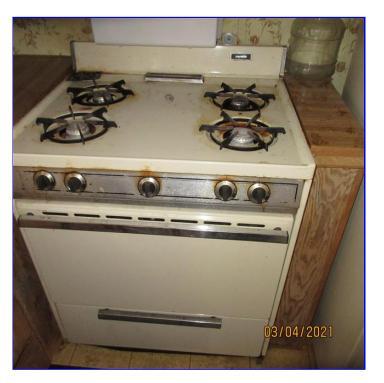
Range and oven not tested due to no propane.
