J.A.G. Home Inspection

Inspection Report

Property Address: 342 Quail Run Calliham Texas 78007

PROPERTY INSPECTION REPORT

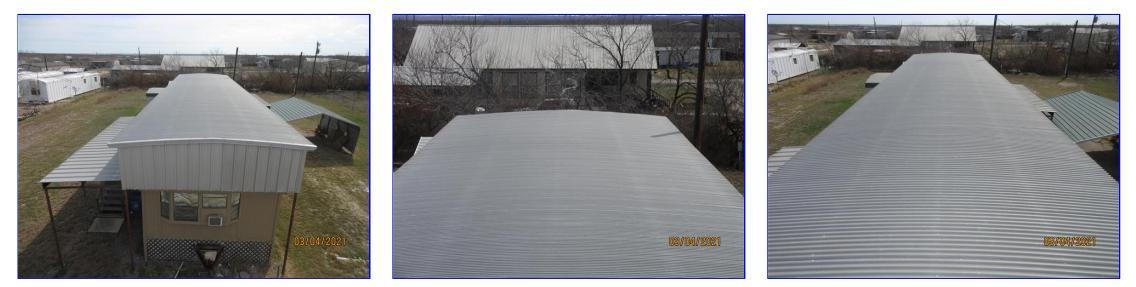
The metal roof above the home is functioning as intended and is protecting the home.

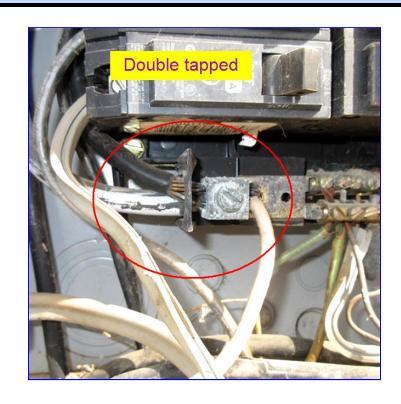
The main lug is double tapped at the main outdoor panel, there should only be one conductor (wire) under each screw or lug. <u>I recommend contacting a licensed electrician for further evaluation and repairs to this system.</u>

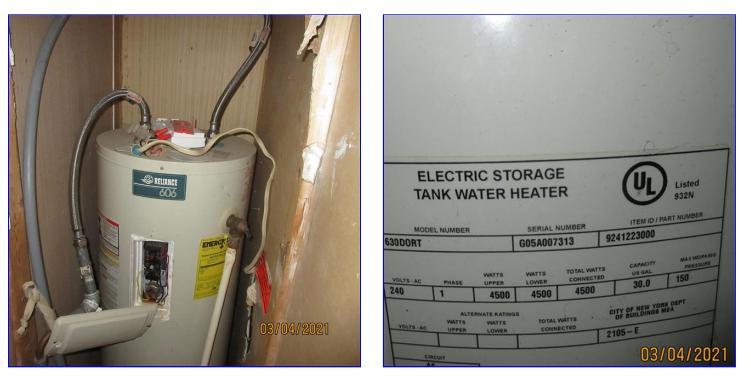
The water heater was functioning as intended at the time of inspection.
